A Review and Study of Thermal Stress Conditions in Heat-Strengthened Spandrel Glass

**ASTM E1300 Meeting
January 2015**

**A. William Lingnell, P. E.
Lingnell Consulting Services
1270 Shores Court
Rockwall, TX 75087
972 771-1600
lingnell@swbell.net**

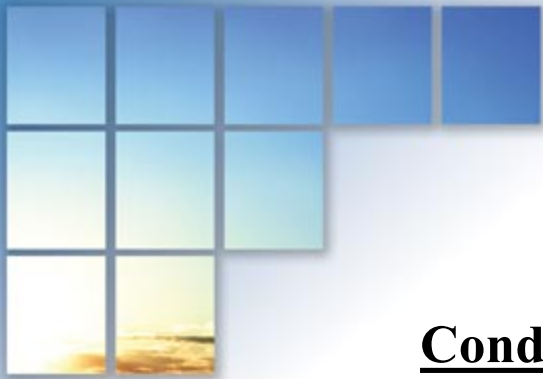
Unusual shadow patterns e.g. “V” “L” or “angular” shaped shadows cause higher thermal stresses than the simple cold edge case previously discussed.

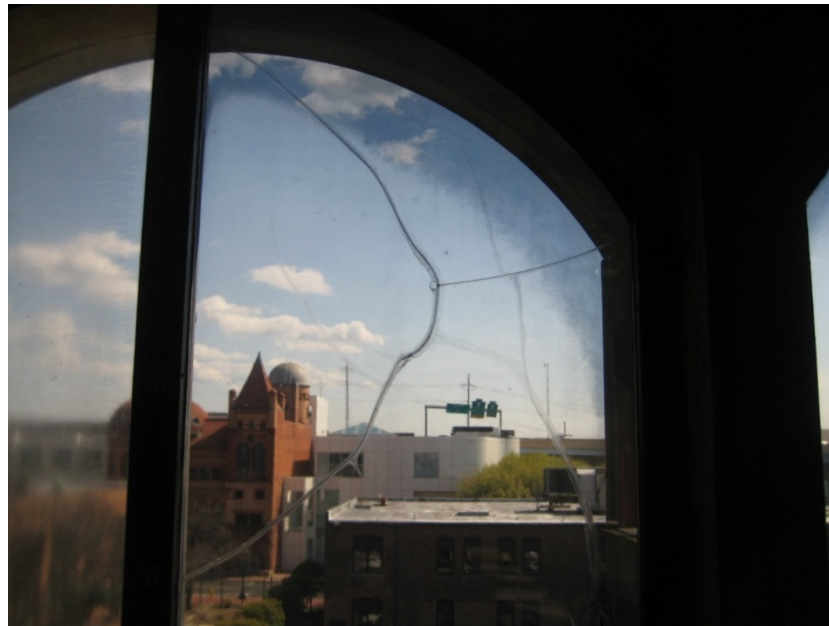
Reflective and tinted films, when placed on surface #4, tend to absorb solar energy and reflect the energy back into the glazing cavity. This elevates the temperature of the indoor lite of glass and the glazing cavity to a higher temperature than it normally would be without the film.

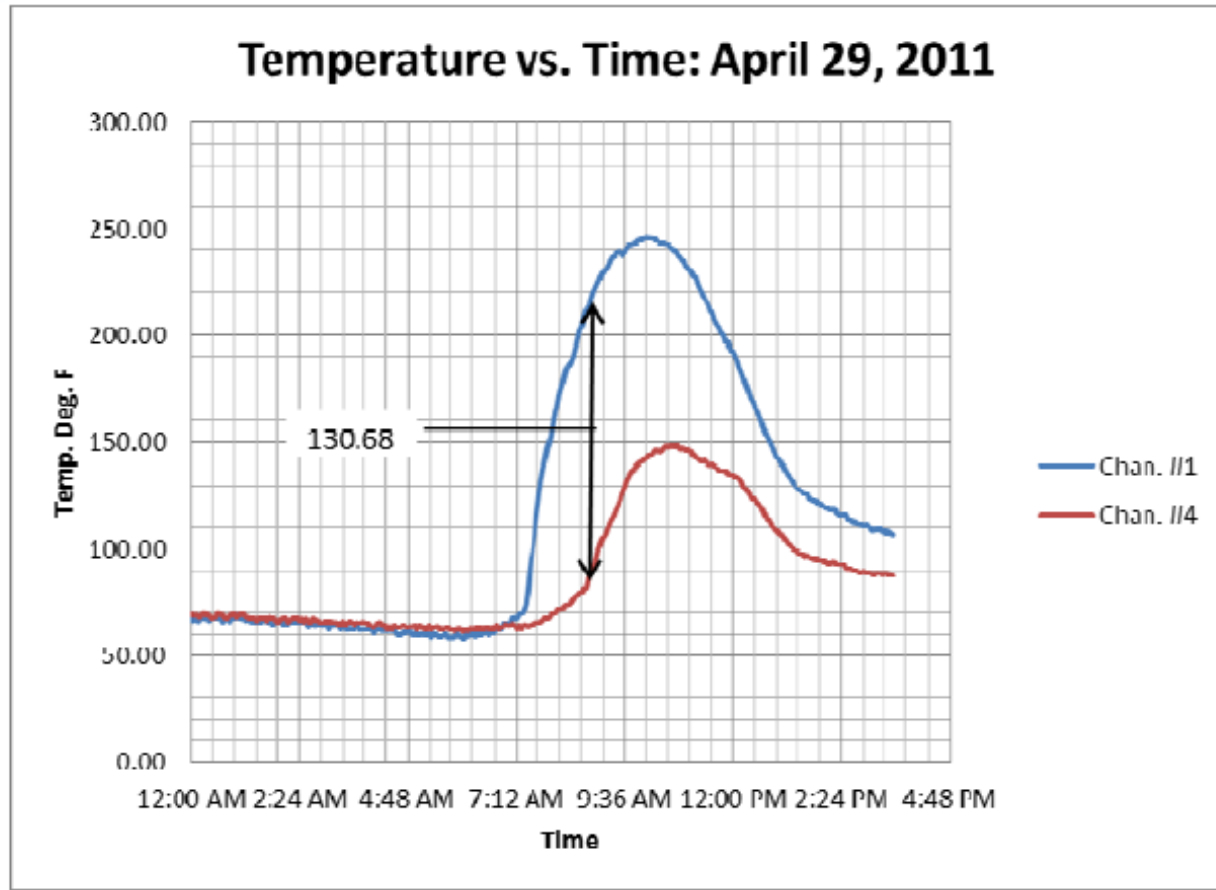
**WJE report with insulation against #4 surface of spandrel unit-
temperature recordings near edge and at center of glass**

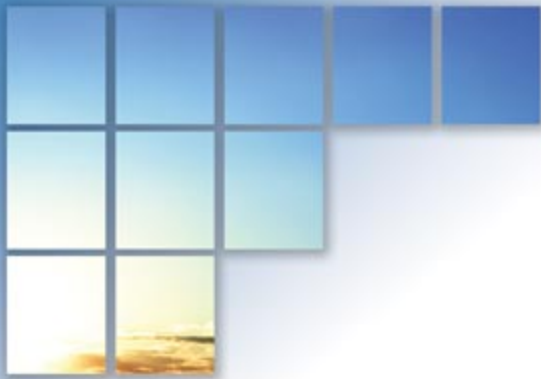
**WJE report with insulation 8.5" away from the #4 surface of spandrel unit-
temperature recordings near edge and at center of glass**

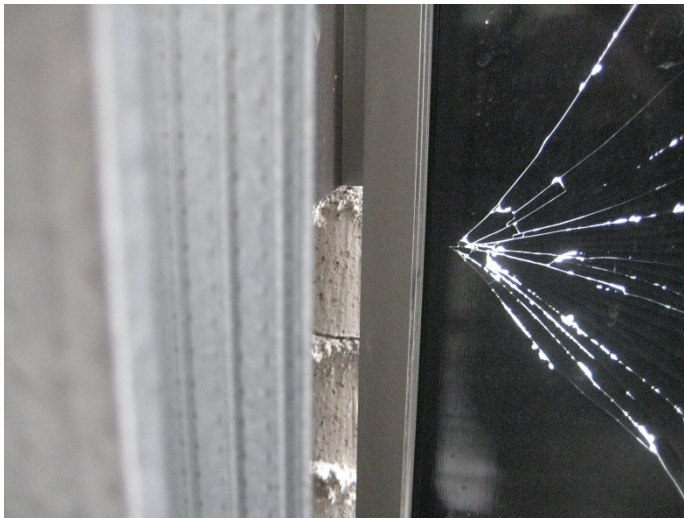
The thermal stress (σ_{thermal}) in glass can be estimated by taking the modulus of elasticity (E) times the coefficient of thermal expansion (ϵ) times the change in temperature (ΔT). Written in a formula this becomes:

$$\sigma_{\text{thermal}} = E \epsilon \Delta T$$

Where $E = 10.4 \times 10^6$ psi for float glass
 $\epsilon = 49 \times 10^{-7}$ in/in/°F
 $\Delta T =$ change in temperature in °F

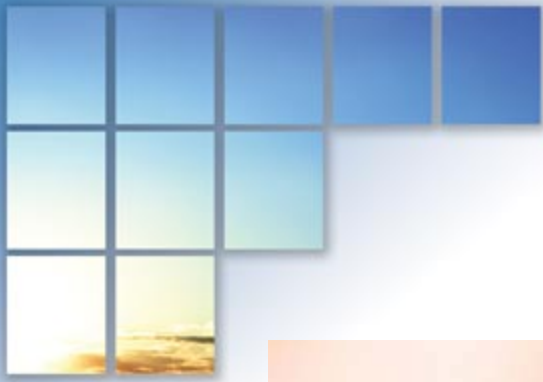
**Fracture Origin Example-HS Glass with
Ceramic Enamel**

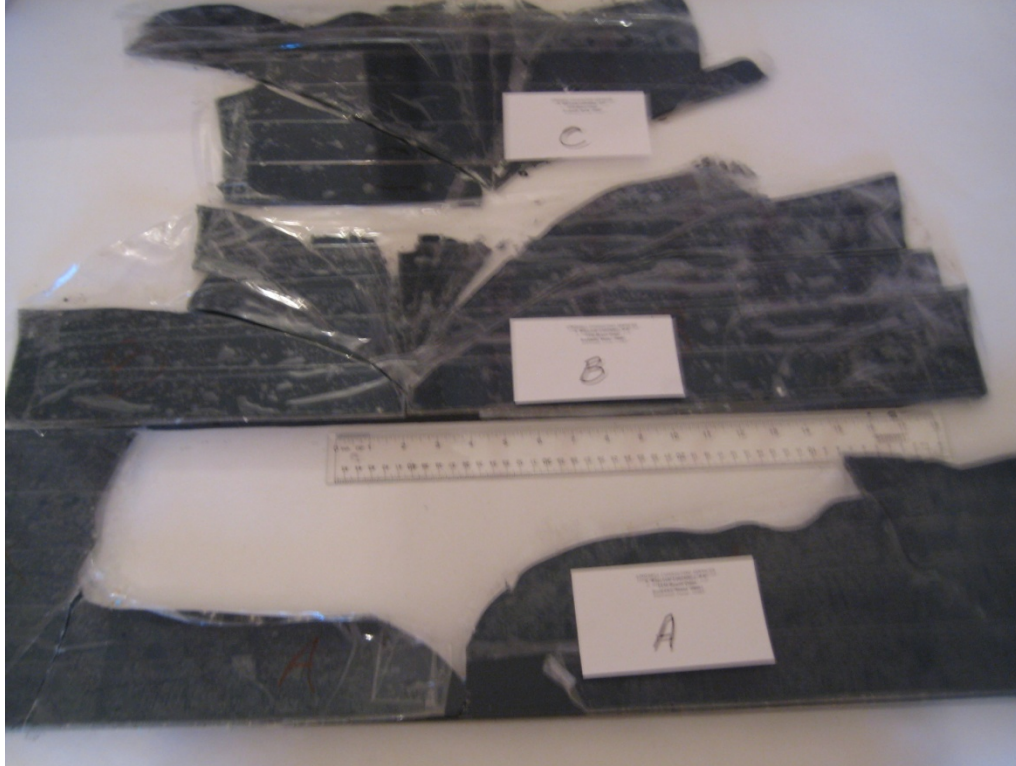
Break patterns of three samples of spandrel glass fracture

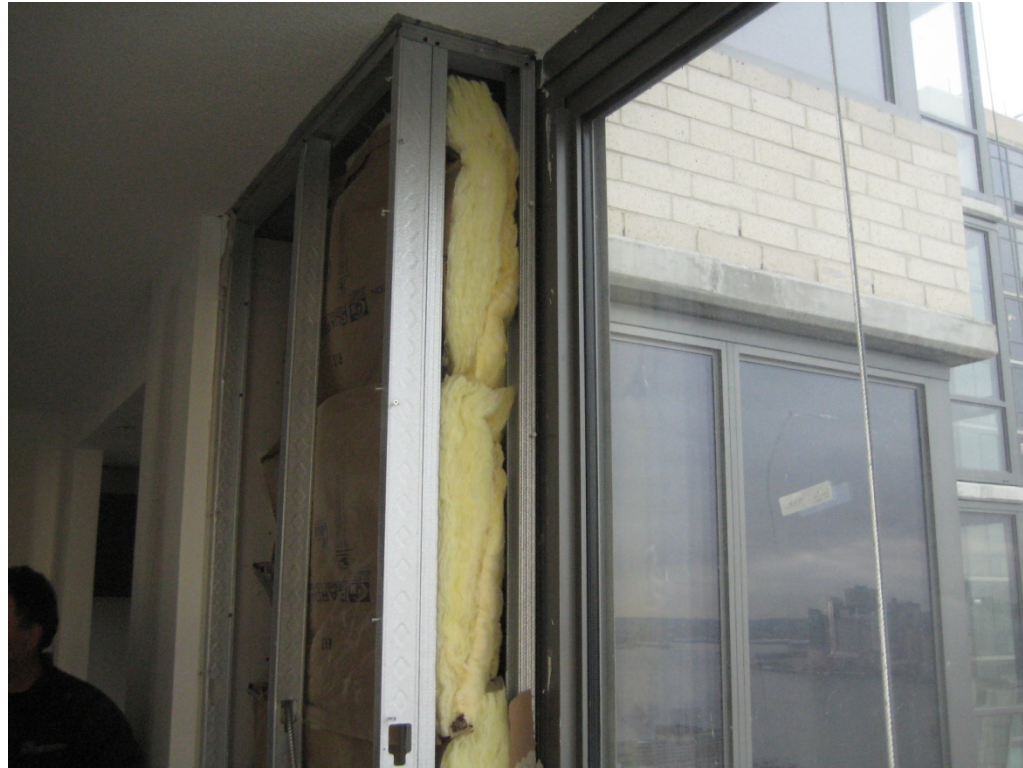
**Spandrel area with insulation tight up against #4
surface of insulating glass**
